SPRUCE RUN DAM

PHASE I INSPECTION REPORT
NATIONAL DAM SAFETY PROGRAM

NJ 00132

Date: 25 April 1978

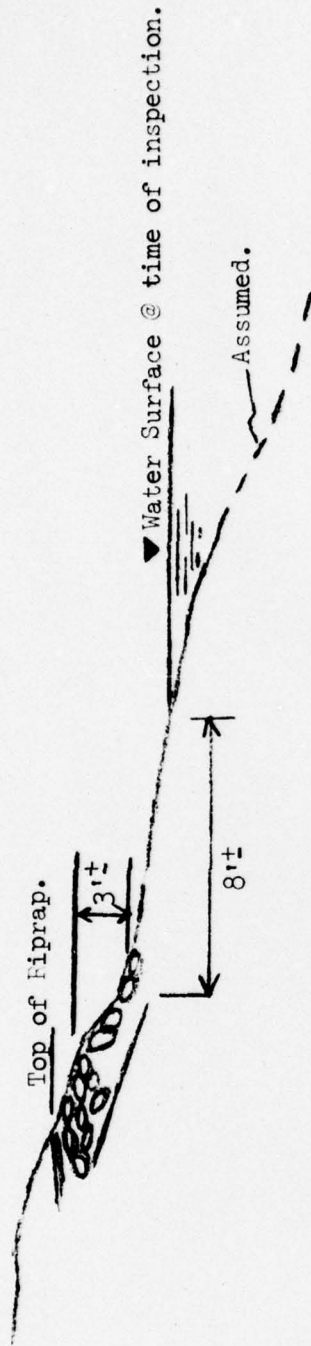
RIPRAP (CONTINUATION)

VISUAL EXAMINATION OF	REMARKS
SURFACE CRACKS	None noted.
UNUSUAL MOVEMENT OR CRACKING AT OR BEYOND THE TOE	None noted.
SLOUGHING OR EROSION OF EMBANKMENT AND ADJUTMENT SLOPES	Noted shallow (normally 2-3"), exceptionally up to 5", cutting in certain areas of embankment slope. These are parallel to the top of dam and are caused by a slope mower crossing over soft, wet surface of embankment. State Representative, Mr. Ronald Hassling, indicated this had occurred because of necessity of mowing on wet surfaces during the past fall. Evidence of repair of worst of these. Several small depressions noted on downstream face appear to be built in and not the result of subsidence or sloughing.
VERTICAL AND HORIZONTAL ALIGNMENT OF THE CREST	No problems noted.
RIPRAP FAILURES	Several areas show apparent adjustment of riprap to normal wave conditions - Consistent bench section from El. 368t to El. 372t. Areas where riprap has slumped leaving greatly reduced cover - approximately 40' long - El. 372 to top of riprap - 200' from service bridge - See also note under first item - next page. Riprap gradation and placement requirements appear to have provided riprap protection consisting of two basic types of surface: (1) Generally small, 18" and less, stone comprising practically all stone protection and (2) Large, 3' up to 4' stone, with the smaller stone previously noted. The first type of stone, where prevalent in the protection has generally adjusted to the scarp - beach section shown below in profile. The second gradation of stone generally appears to have the larger stone remaining in place with the smaller stone being reworked. This results, in many areas, in the tops of larger stones being from 1½ to 2' higher than the smaller stone surrounding them.

Although it is believed the surface is capable of protecting the random fill section for the next 3-5 years, the owner should program a reworking of the stone surface in his maintenance budget within that period to assure that rehabilitation work can be performed when needed. The several areas where slumps or other deficiency of protective cover were noted should be repaired as soon as possible. Further suggest that a number of profiles be run to determine existing shape of slope down to El. 255 and compare with as-built surveys if available. Also determine if photos of slopes as-built are available and, if so, compare with present conditions.
